# Test Report

RS-TR-2026-03

Ram-Shell Durability Test

Solveering LLC

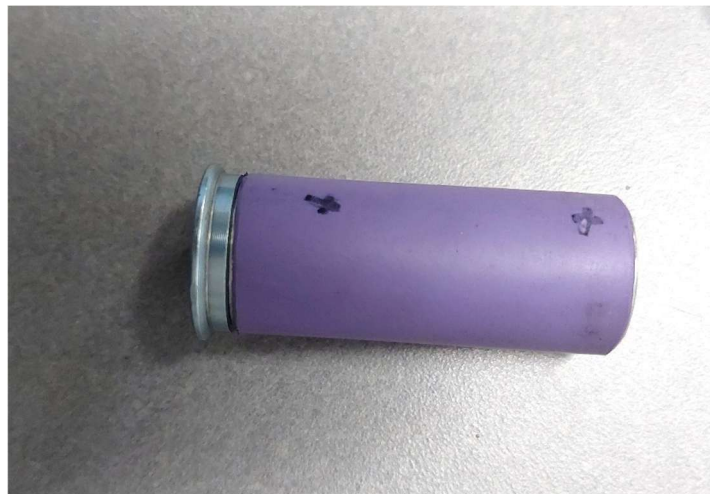
Using a spring-loaded OD gauge, the shell is inspected at two critical points prior to starting the testing. The locations are marked with a Sharpie in Figure 1:

*Figure 1: Shell before starting test. X marks the approximate location of dimensional tests.*

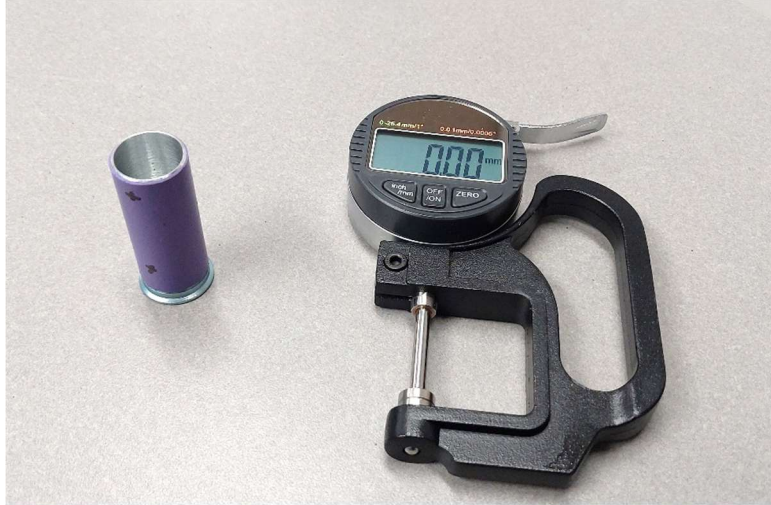
Figure 2 shows the digital OD gauge being used which has a precision of 0.01mm:

*Figure 2: Digital OD Gauge.*

This gauge was chosen rather than a standard caliper or micrometer as it exerts a consistent force and does not compress the sleeve material by as much as a micrometer would. It also allows for quicker inspection and to slightly rotate the shell to observe changes in diameter and roundness.

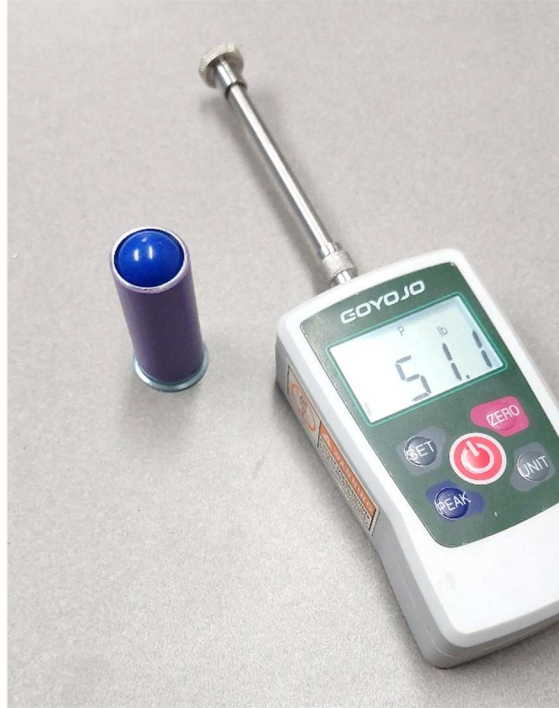
For the purpose of this test, a consistent (+/-5%) value of 50lbf was sought. This was achieved by using a digital force gauge, set to display the maximum force exerted. The tool is shown in Figure 3:

Figure 3: Digital Force Gauge used.

The flat, extended attachment made it easy to apply the desired force once the projectile was partially inserted into the hull.

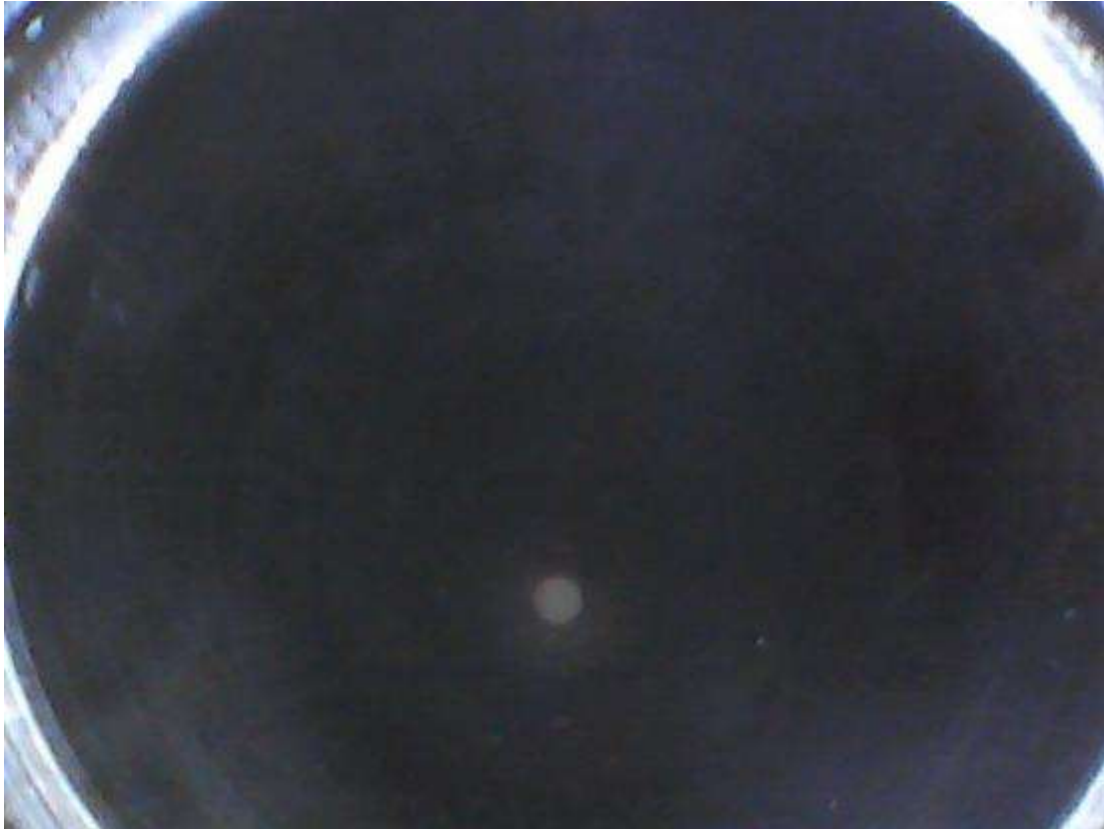
Prior to starting the series of test discharges, the barrel of the shotgun was cleaned using a light oil and rag only. Figure 4 shows a view from the breech side into the barrel, showing little in terms of buildup or other debris:

*Figure 4: View into barrel at start of process.*

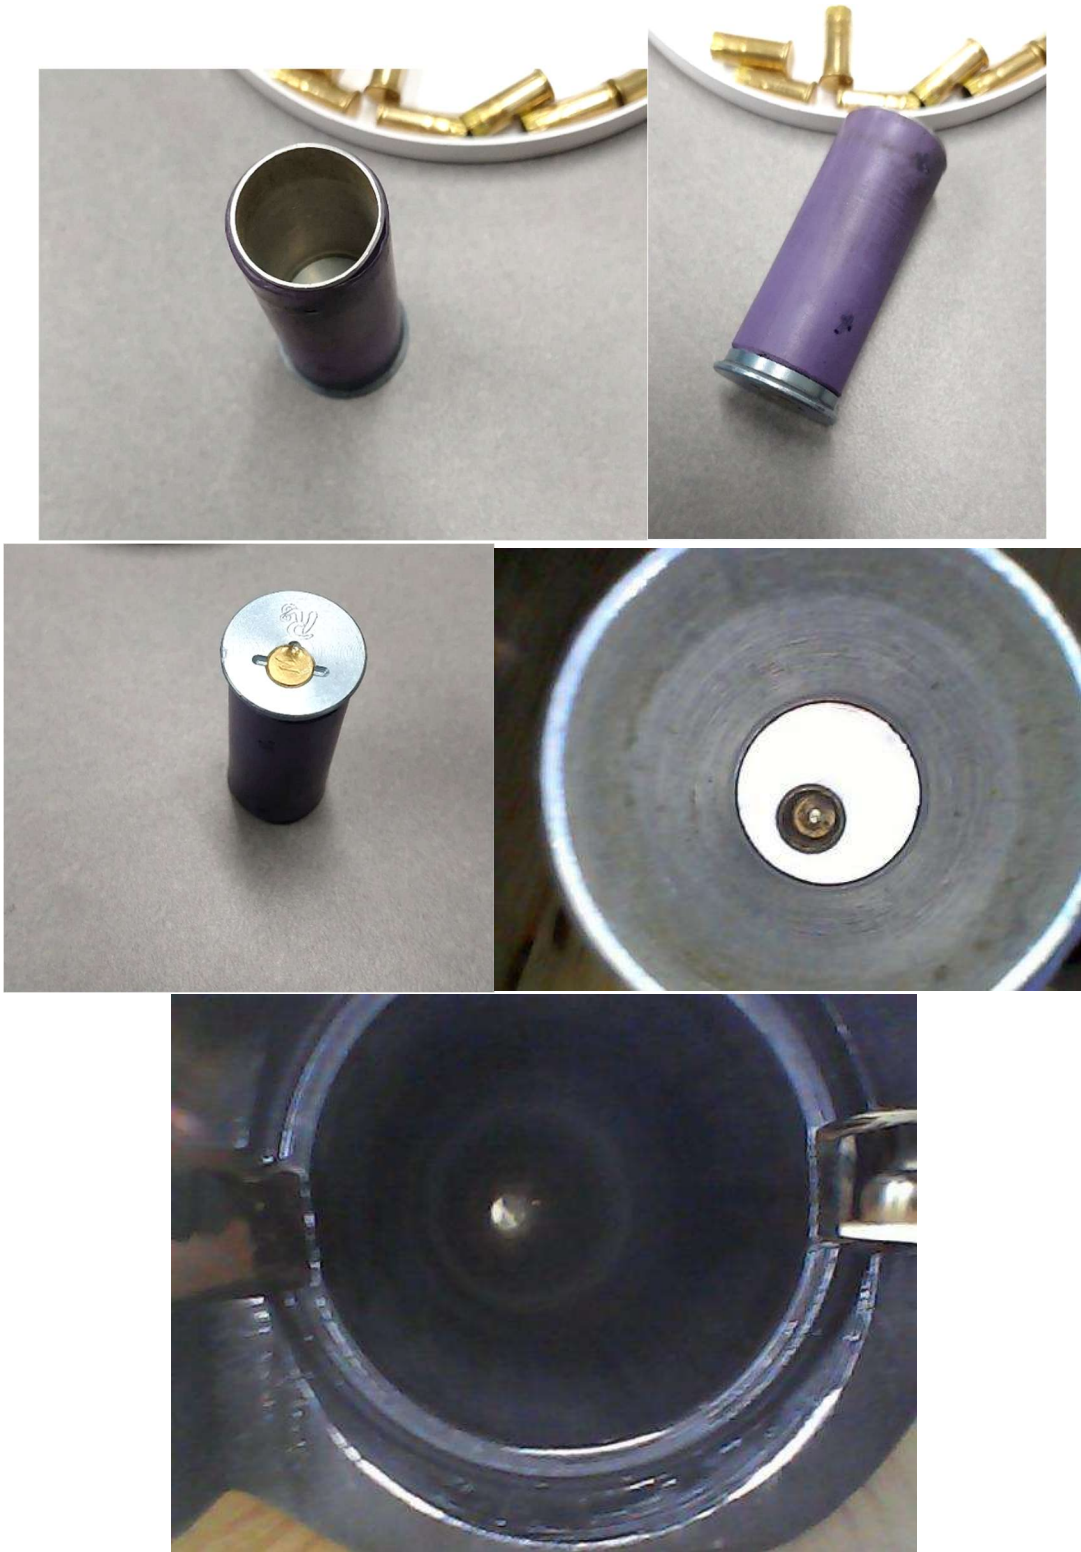
During the course of the test, a number of photographs were taken of the shell with the first showing the overall condition after 10 cycles, including the internal view and view into the bore of the shotgun barrel - shown in Figure 5:

Figure 5: Shell after 10 discharges.

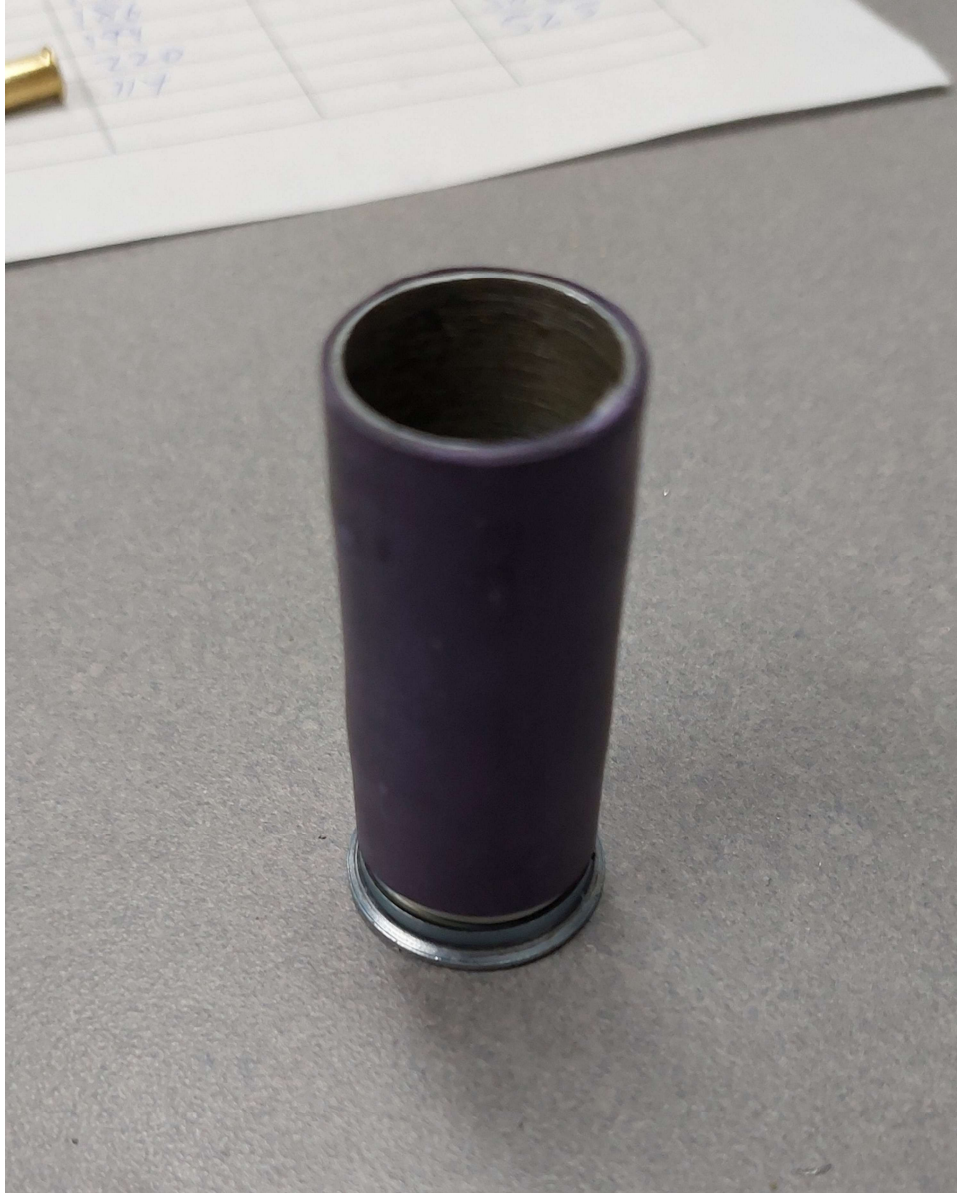
*Figure 7: Exterior view of shell after 30 discharges.*

In this image, it is noticeable that the interior rim has some discoloration and the base shows a slight bulge, matching measured change in diameter. It should be noted that this change only occurred once the rubber projectiles were used (for the last 5 discharges) as they sit at the base of the shell when inserted with the listed amount of force.

At the conclusion of the first 25 discharges, the projectile was switched from a solid plastic (nylon) projectile to a hard rubber (Shore 80D) projectile. With the introduction of this rubber ball, a physical change to the outer hull was noticed. It is likely that the rubber material, being of a more compliant nature and thus able to be pushed to the very bottom of the shell, generated a higher-pressure spike during discharge which in turn was sufficient to cause minor plastic deformation of the aluminum hull in the immediate proximity to where the projectile was positioned. This deformation was observed immediately following the change to the rubber projectile but does not seem to noticeably increase over time.

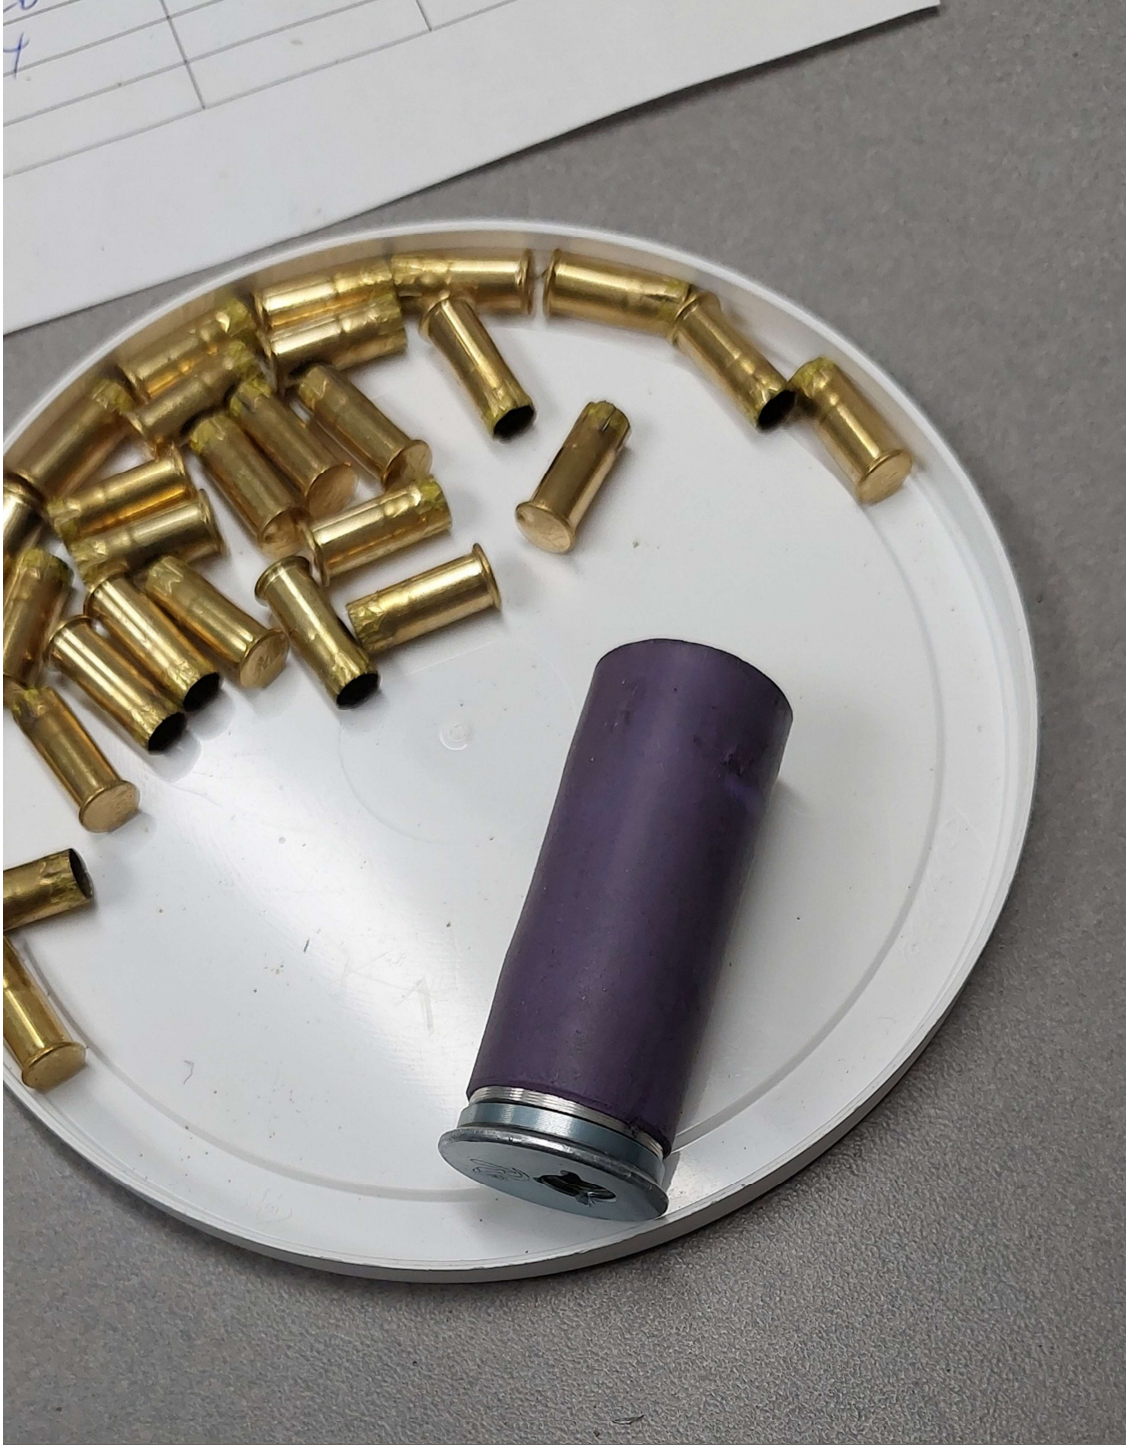
*Figure 8: Exterior view of shell after 30 discharges.*

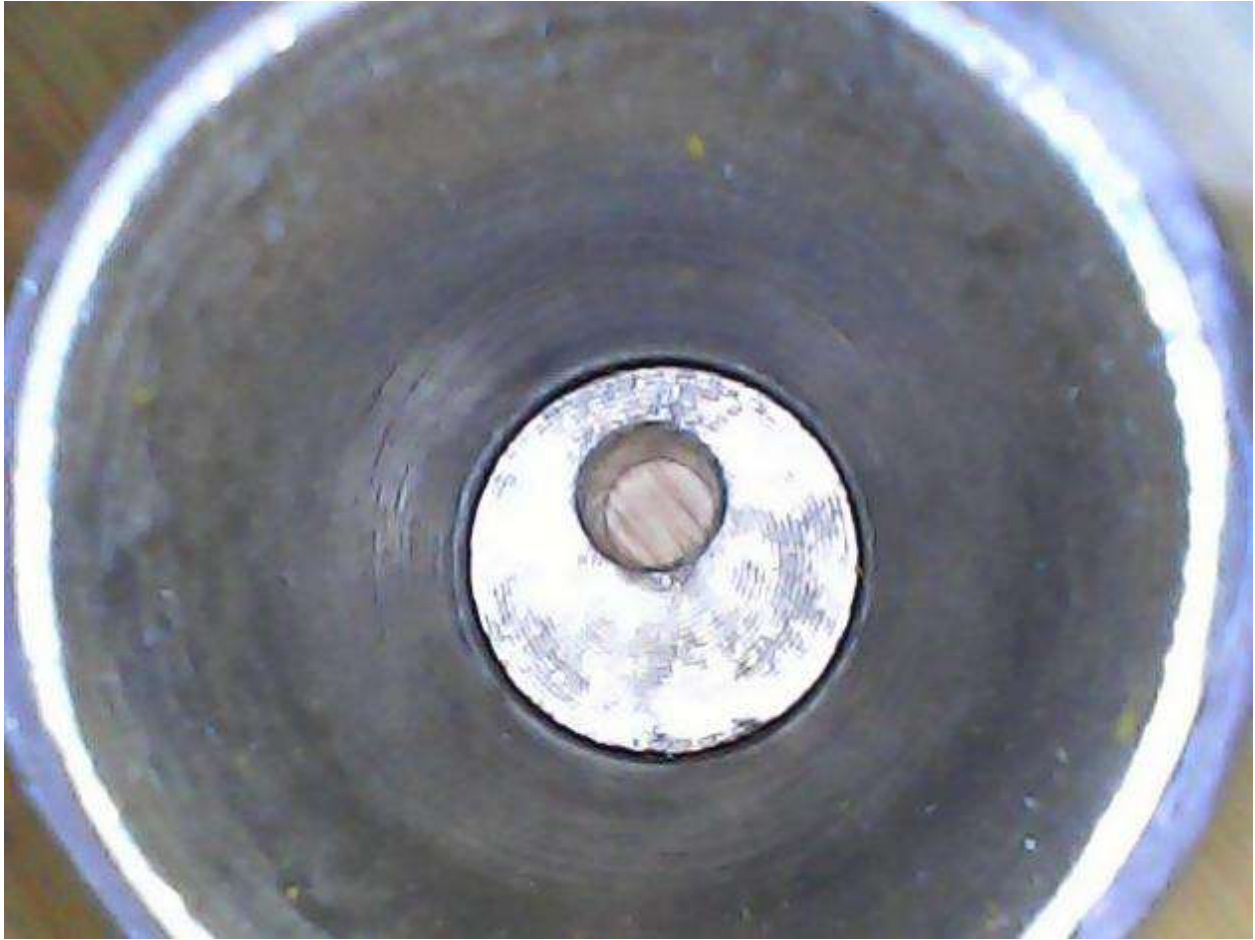
*Figure 9: Interior view of Shell.*

No noticeable deformation of the base material, both on interior or exterior was observed. Only residue from the discharged Ramset charges was left. Minimal deformations to hull near base as noted but without indications of excess strain.

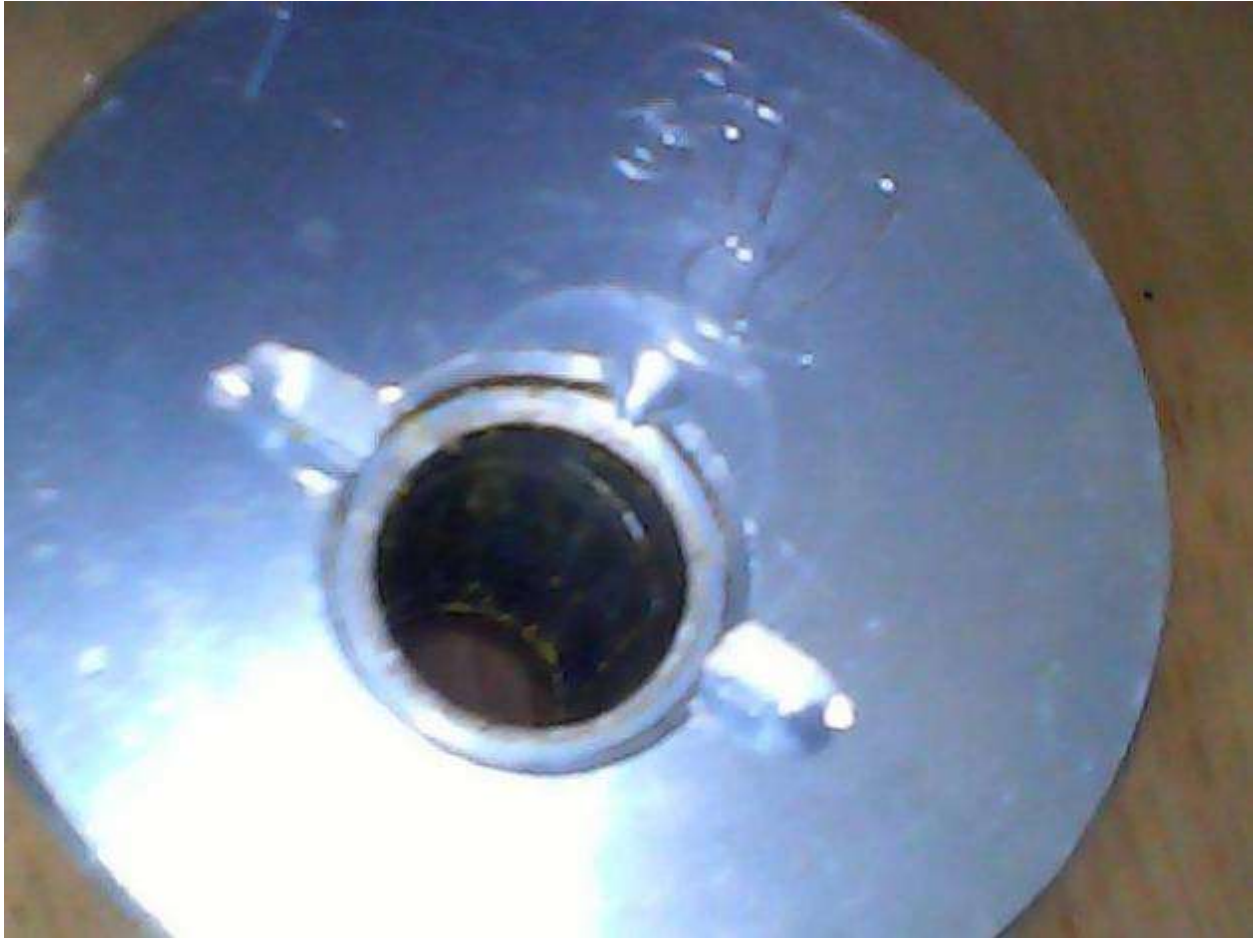
*Figure 10: View onto base of shell.*

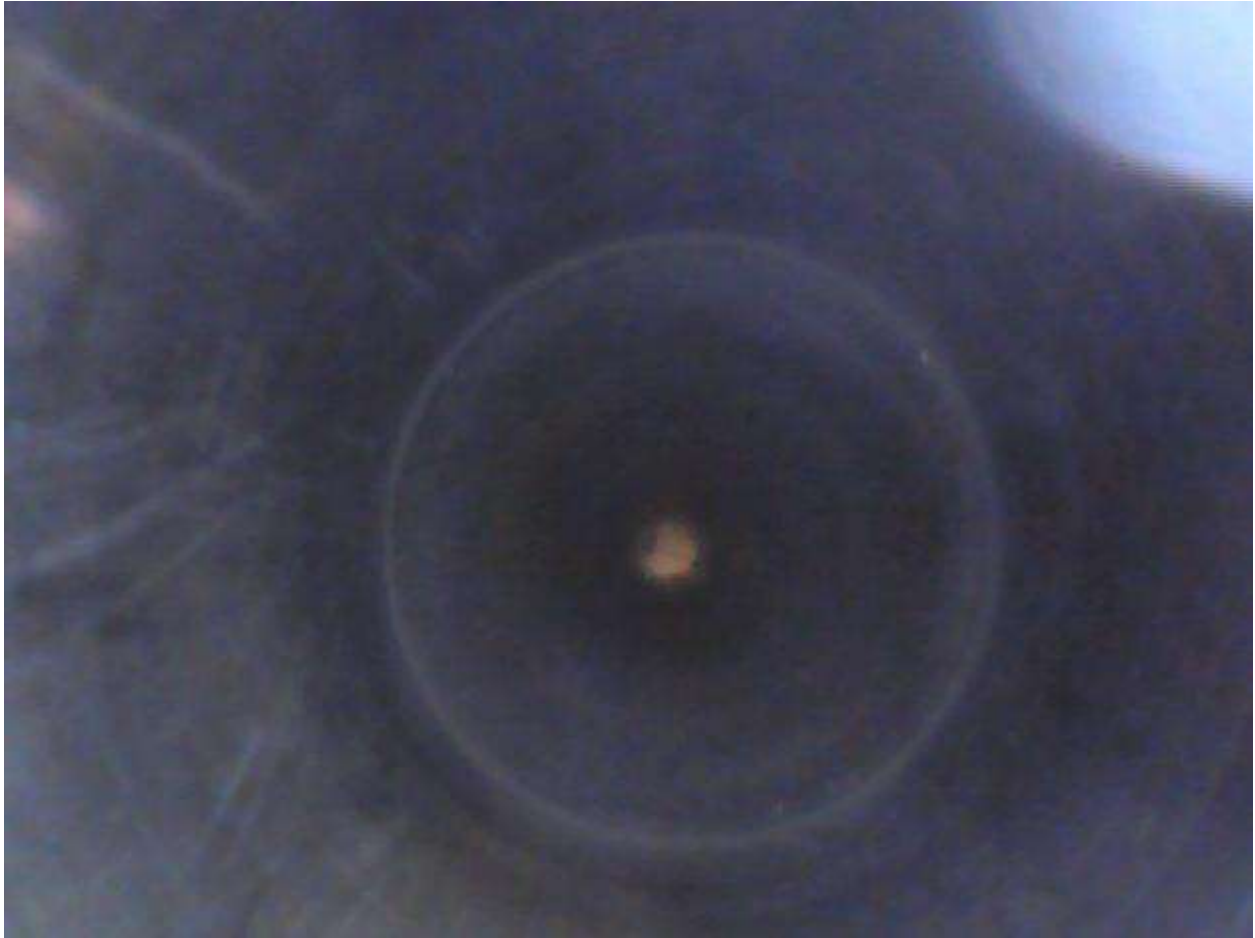
*Figure 11: View into barrel at conclusion of process.*

The barrel, as shown in Figure 11 from the view of the breech, was mostly free from dirt or debris. Only a few small specs remained from the discharge of the Ramset charges.
